Case 301 : Narrative

Case Vehicle (A): 2000 Mercury	Vehicle (B): 1994 Oldsmobile
Type: Cougar, 2-door coupe	Type: Bravada MPV, 4-door
Driver: 45-year-old female	Driver: 43-year-old female
CDC: 12-FDAW-6	CDC: 12-FDEW-4, 00-RDAO-2

This is a fatal crash. Both drivers sustained fatal injuries in this severe head-on impact.

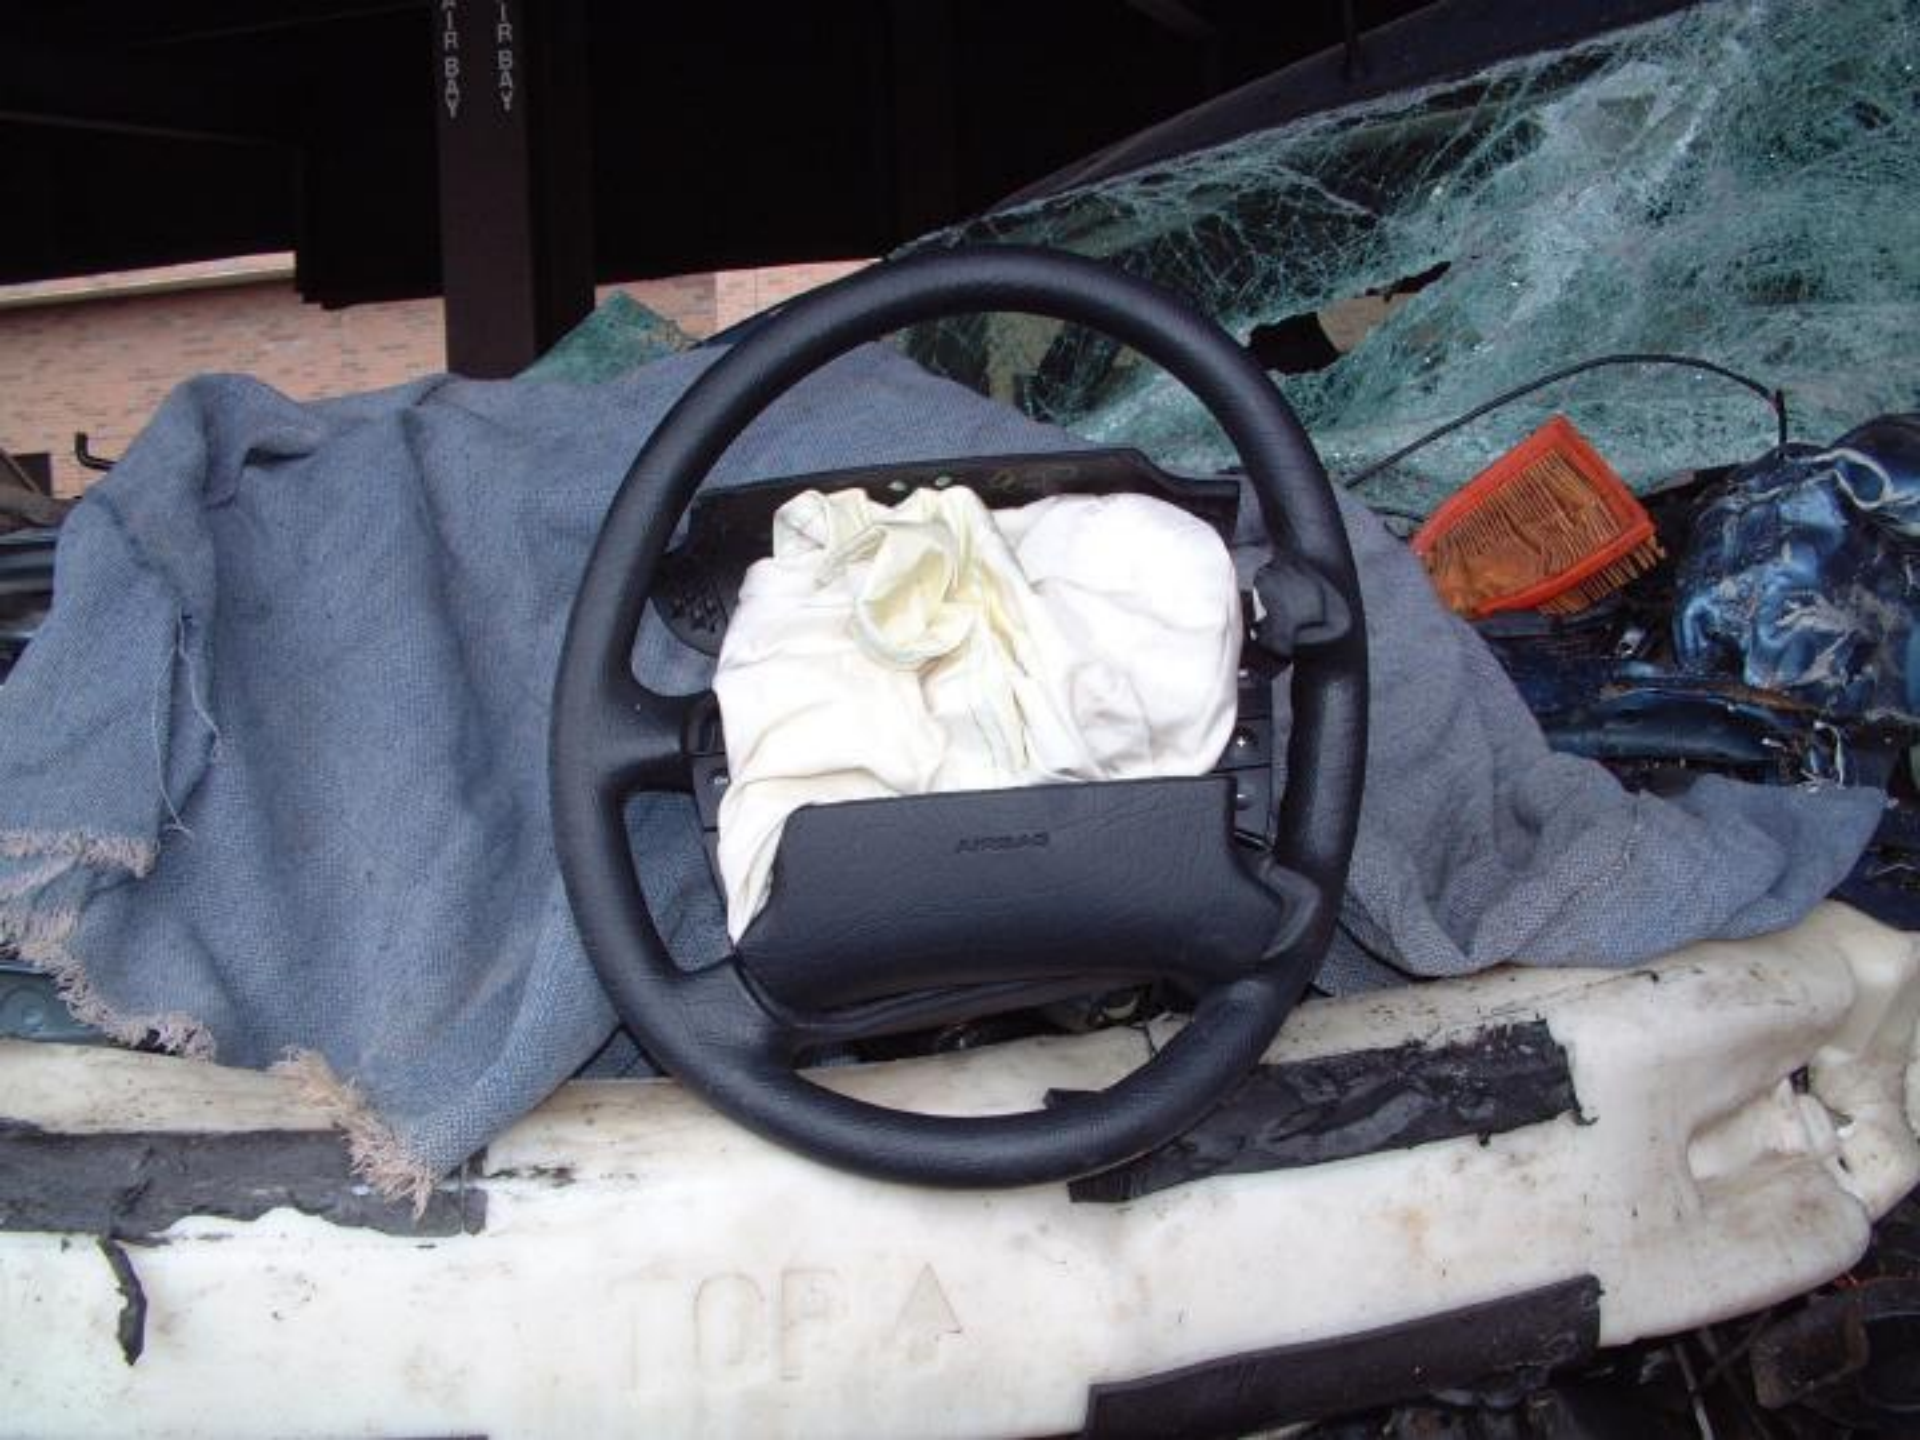
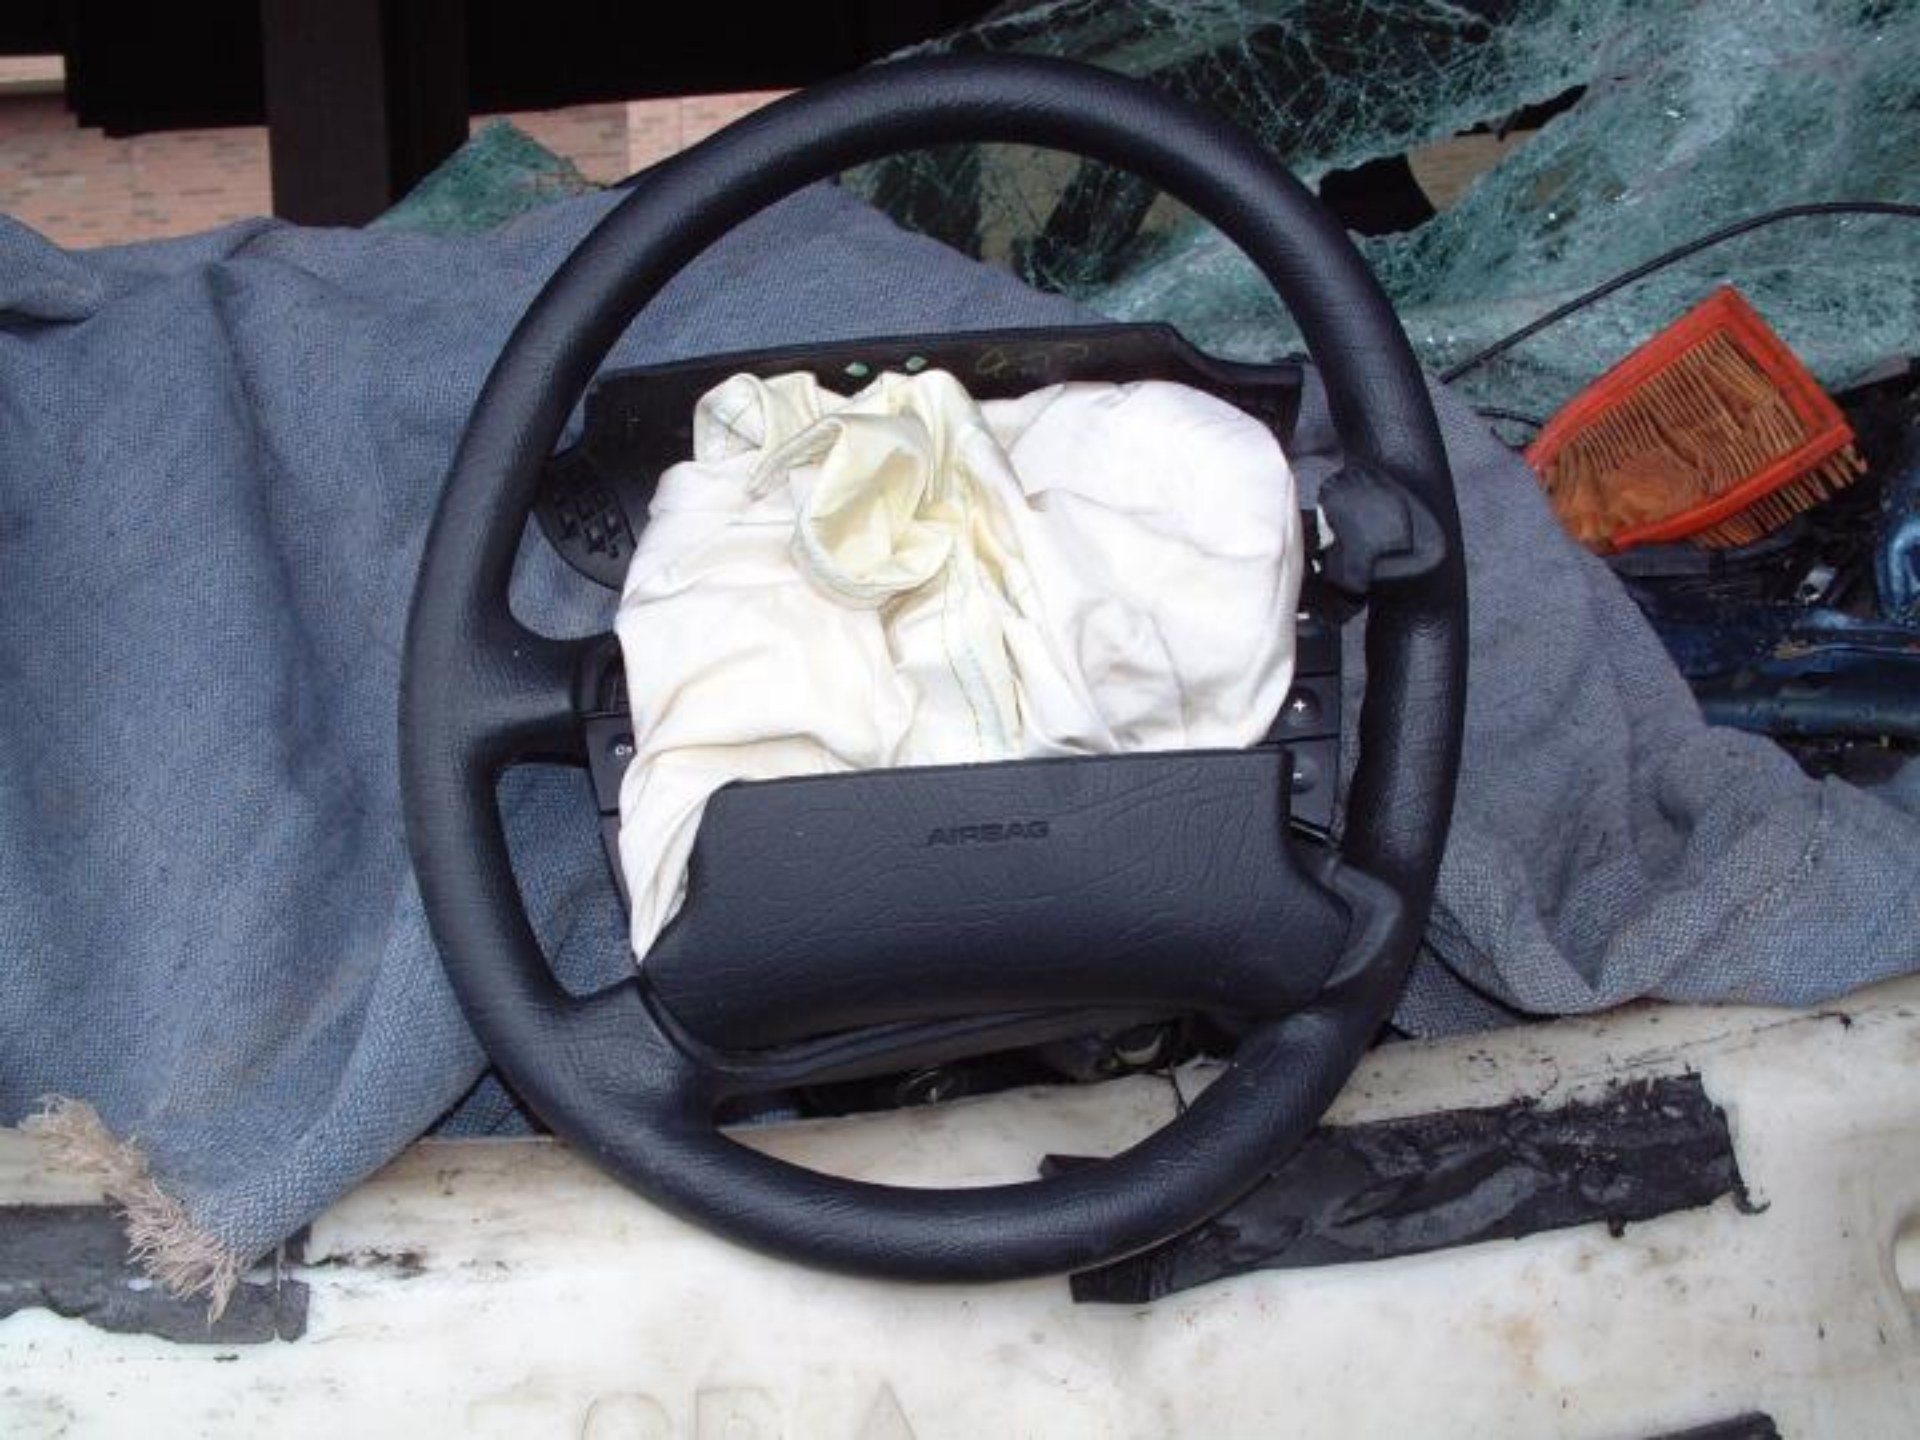
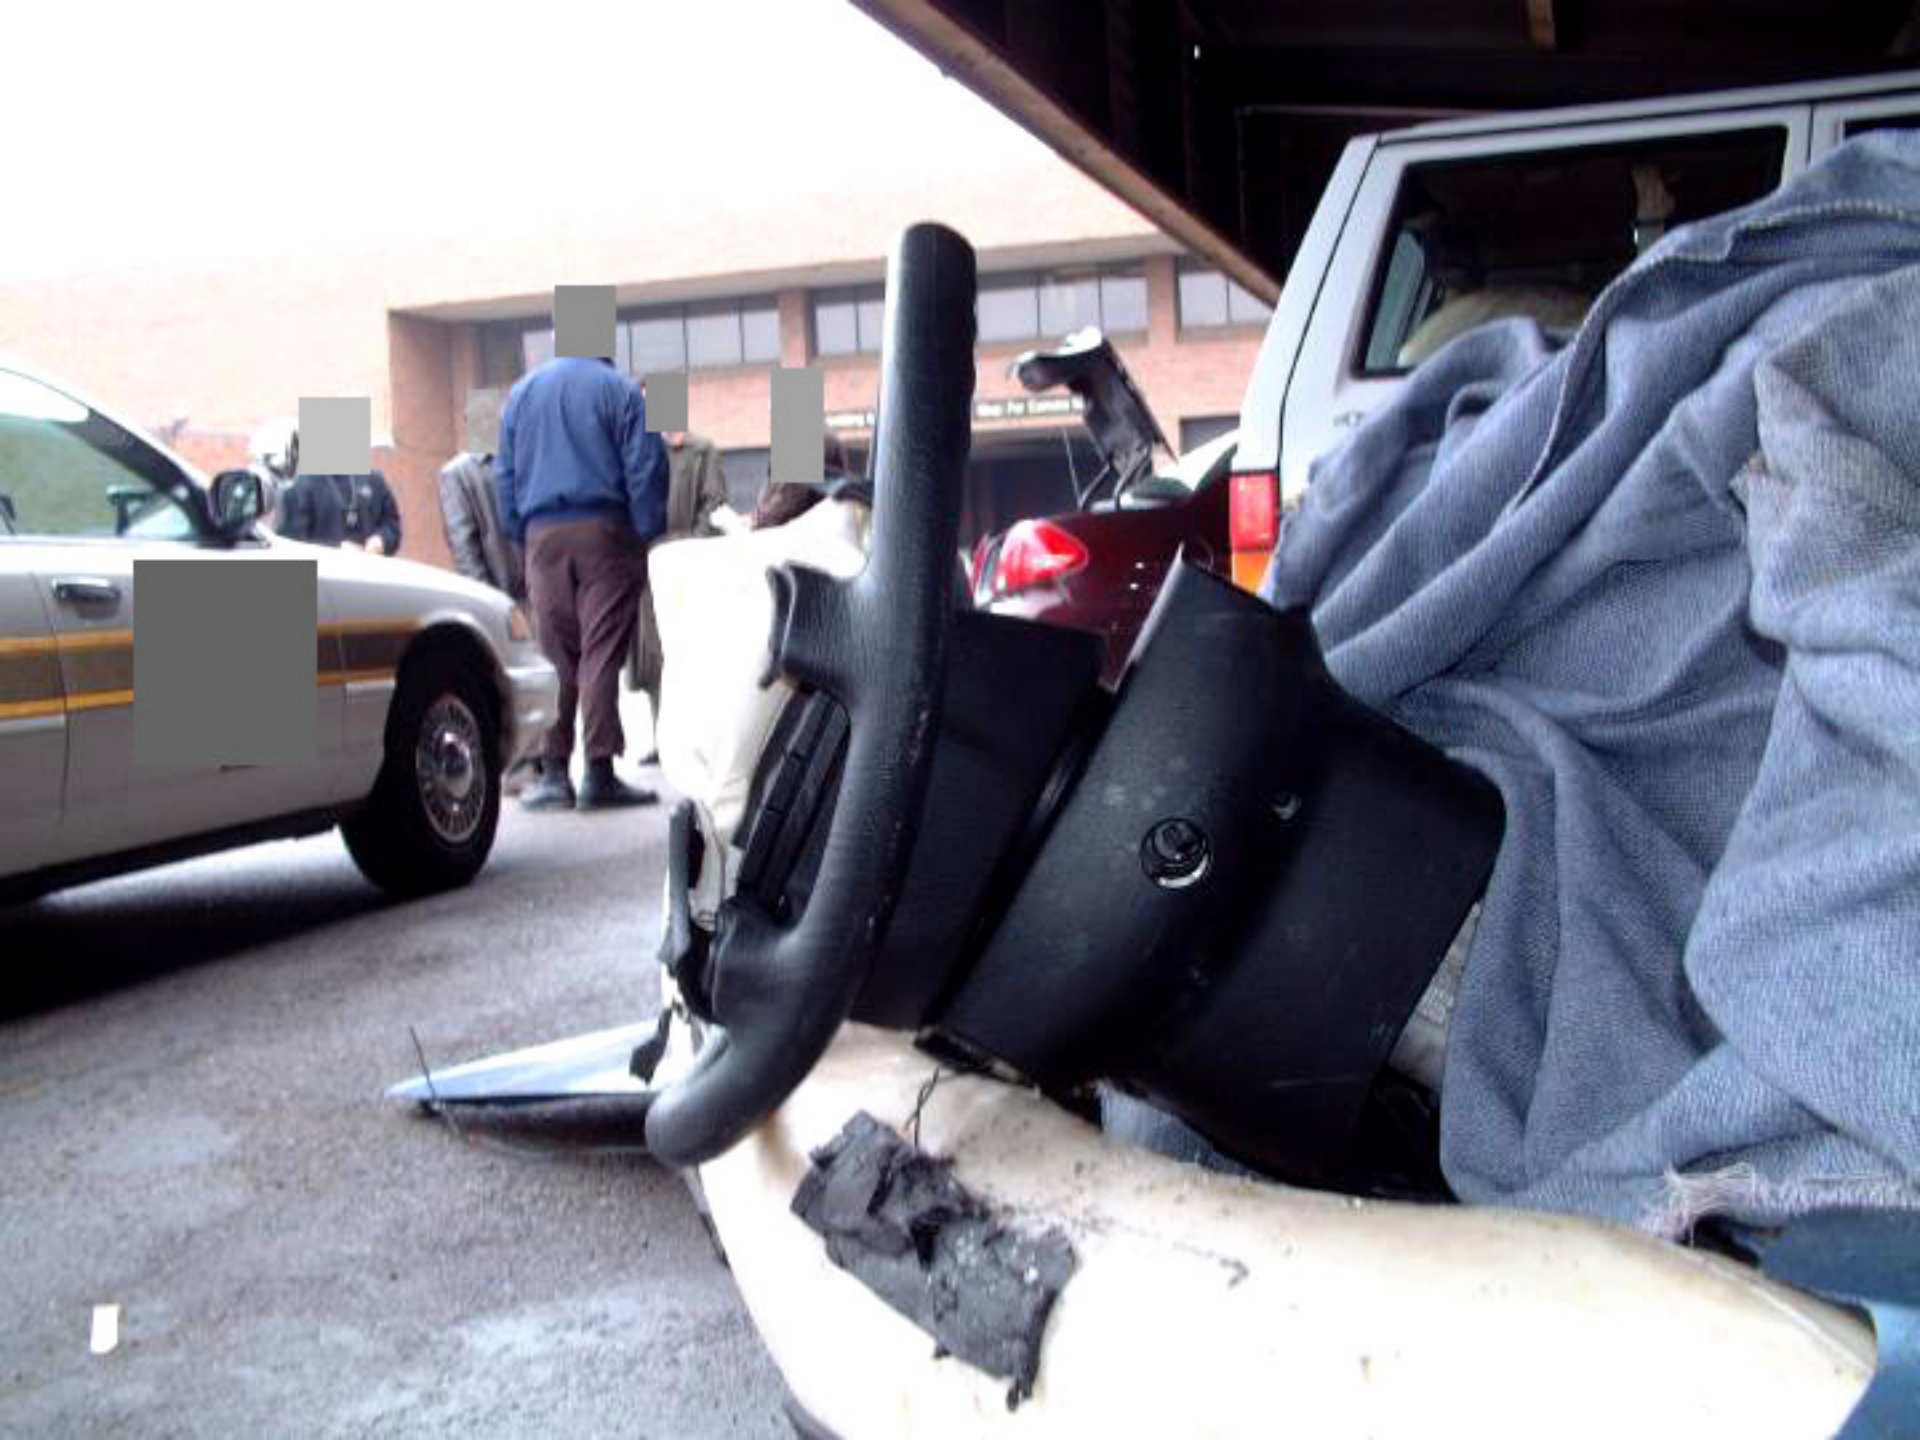
including the ashtray, control knobs, instruments, glove compartment, vents, ducts, and the radio. [61](#) [62](#) [63](#) The interior of the windshield was damaged throughout, the windshield header was displaced to the rear, and the interior areas of both A-pillars were damaged. Also, the roof interior and roof headlining were deformed. [64](#) The right-front seatback was deformed and rotated forward, and the seat adjuster was jammed. [65](#) [66](#) [67](#) The following intrusions were noted and measured:

Location	Component	Distance (cm)	Direction
left front	windshield	59	to rear
	toepan	36	to rear
	instrument panel	32	to rear
	A-pillar	floor	roof header
steering wheel	30	10	9
unknown	to rear	up	to rear

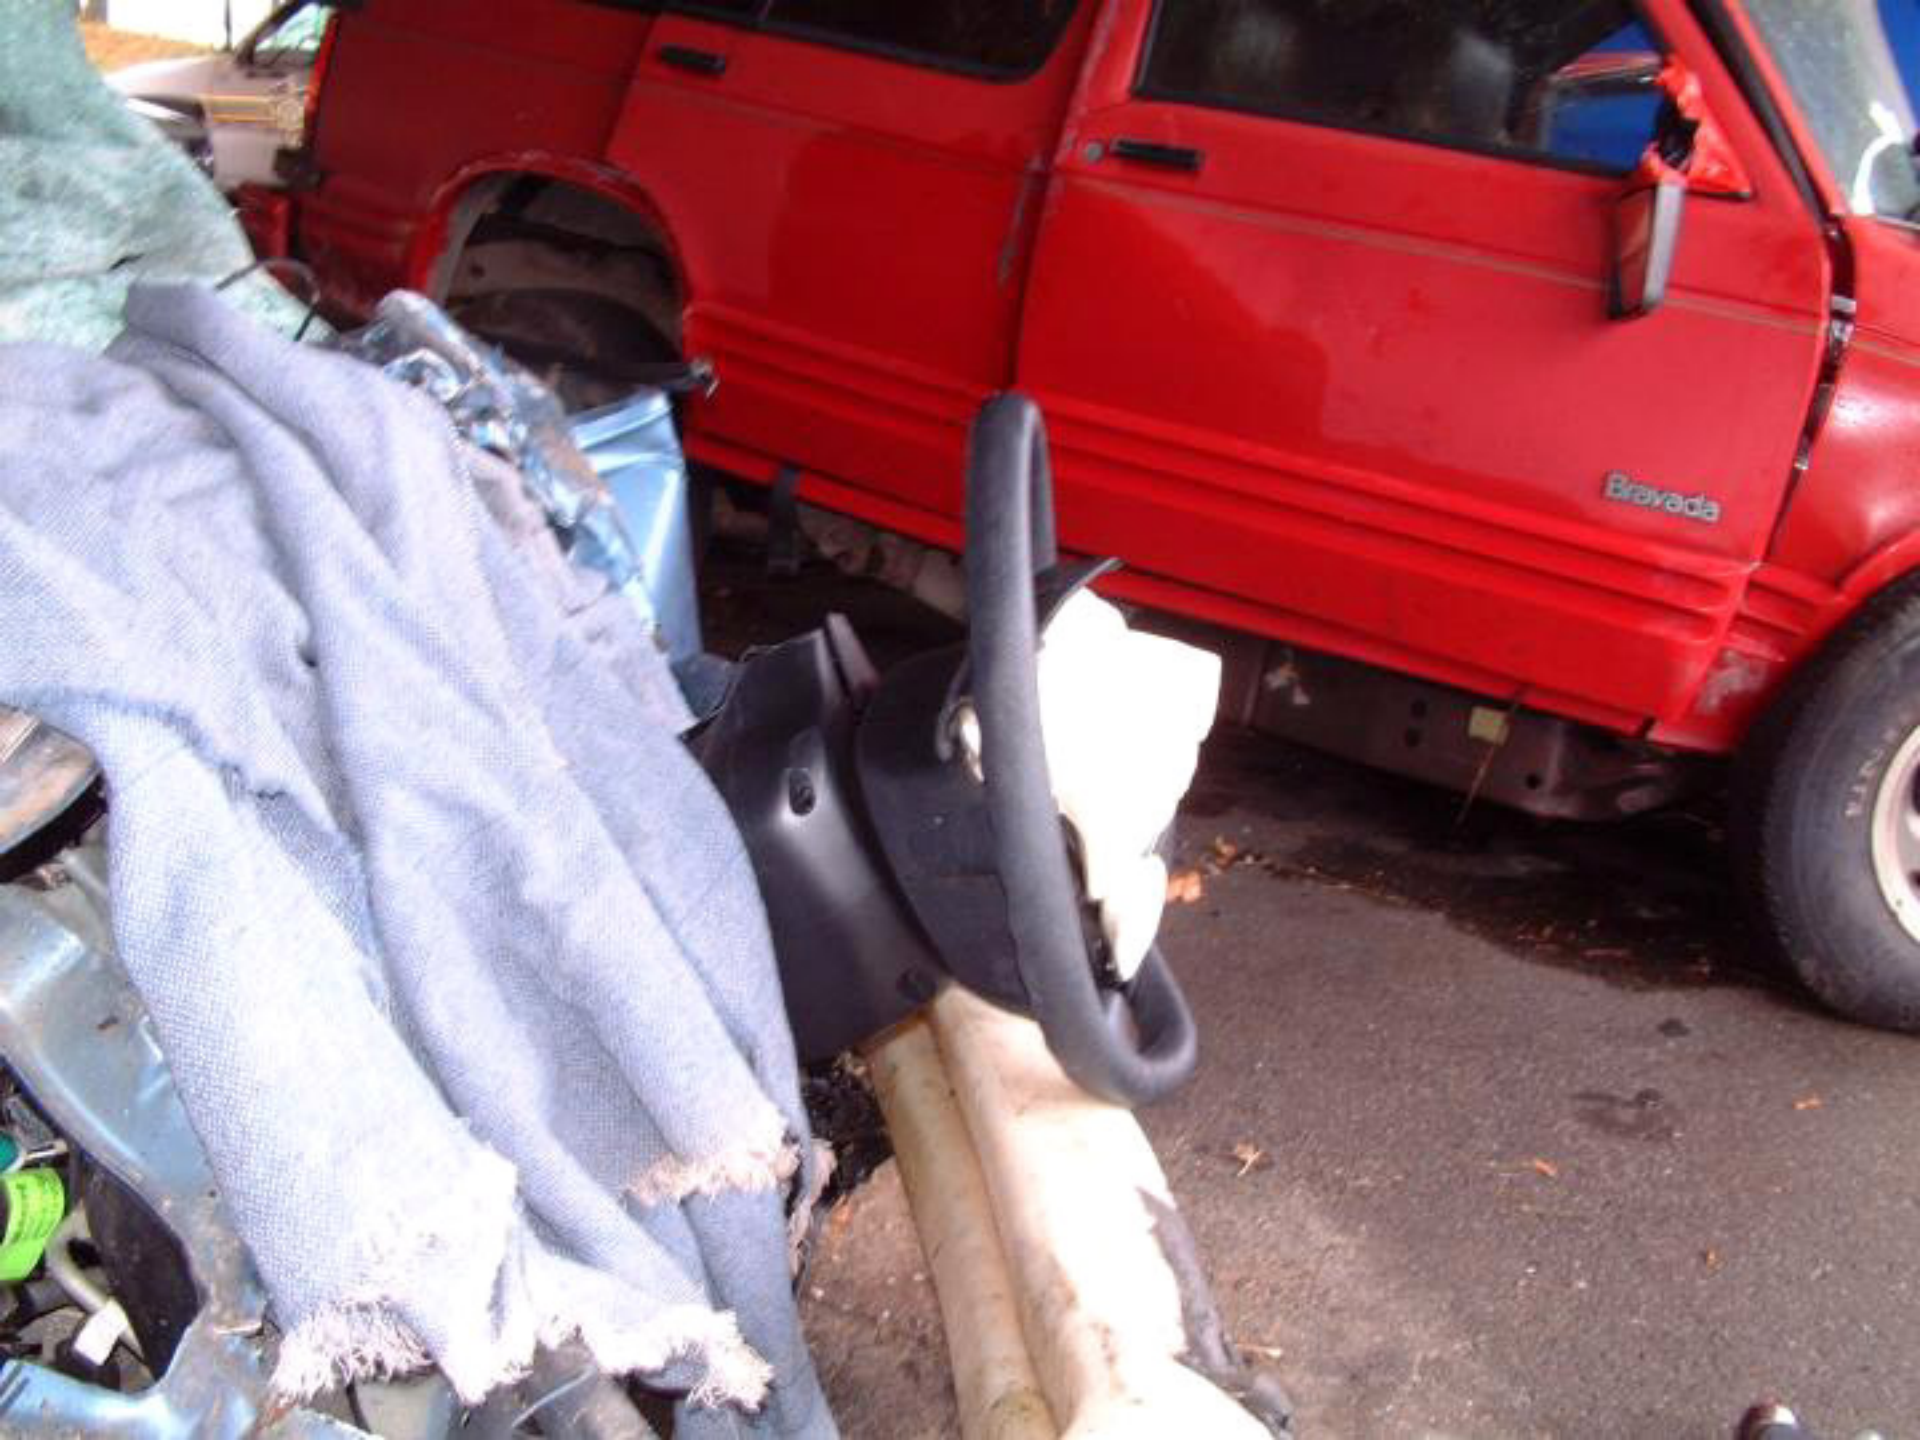
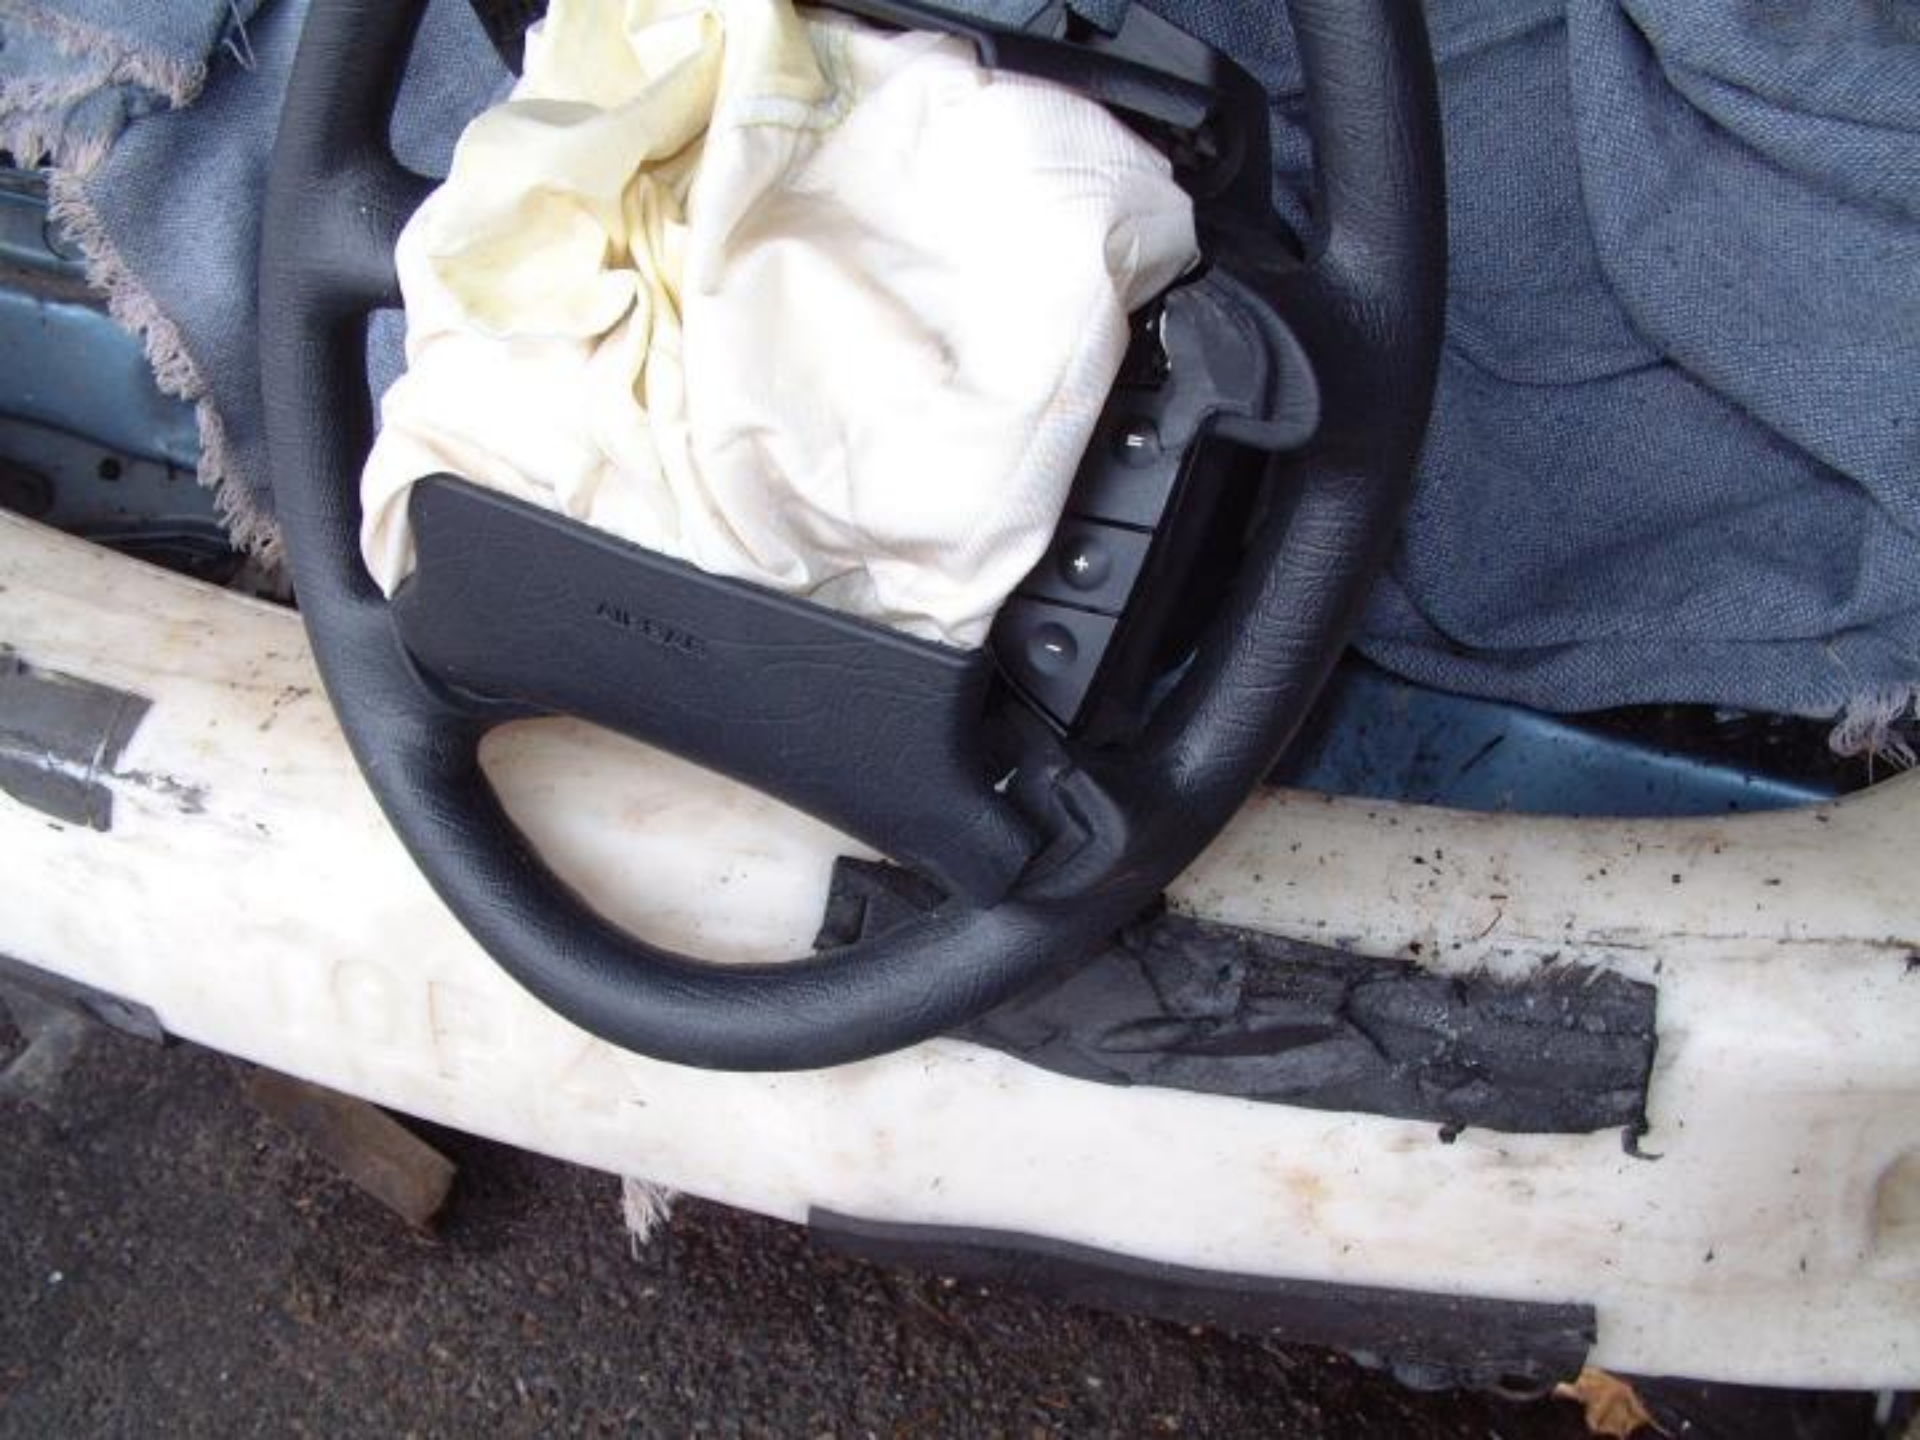
[68](#) [69](#) The 5-ft, 4-in, 205-lb, 45-year-old female driver was **not** wearing the three-point belt, and the steering-wheel airbag deployed. [70](#) [71](#) [72](#) There were no marks on the D-ring or belt webbing to indicate that the belt was being used.

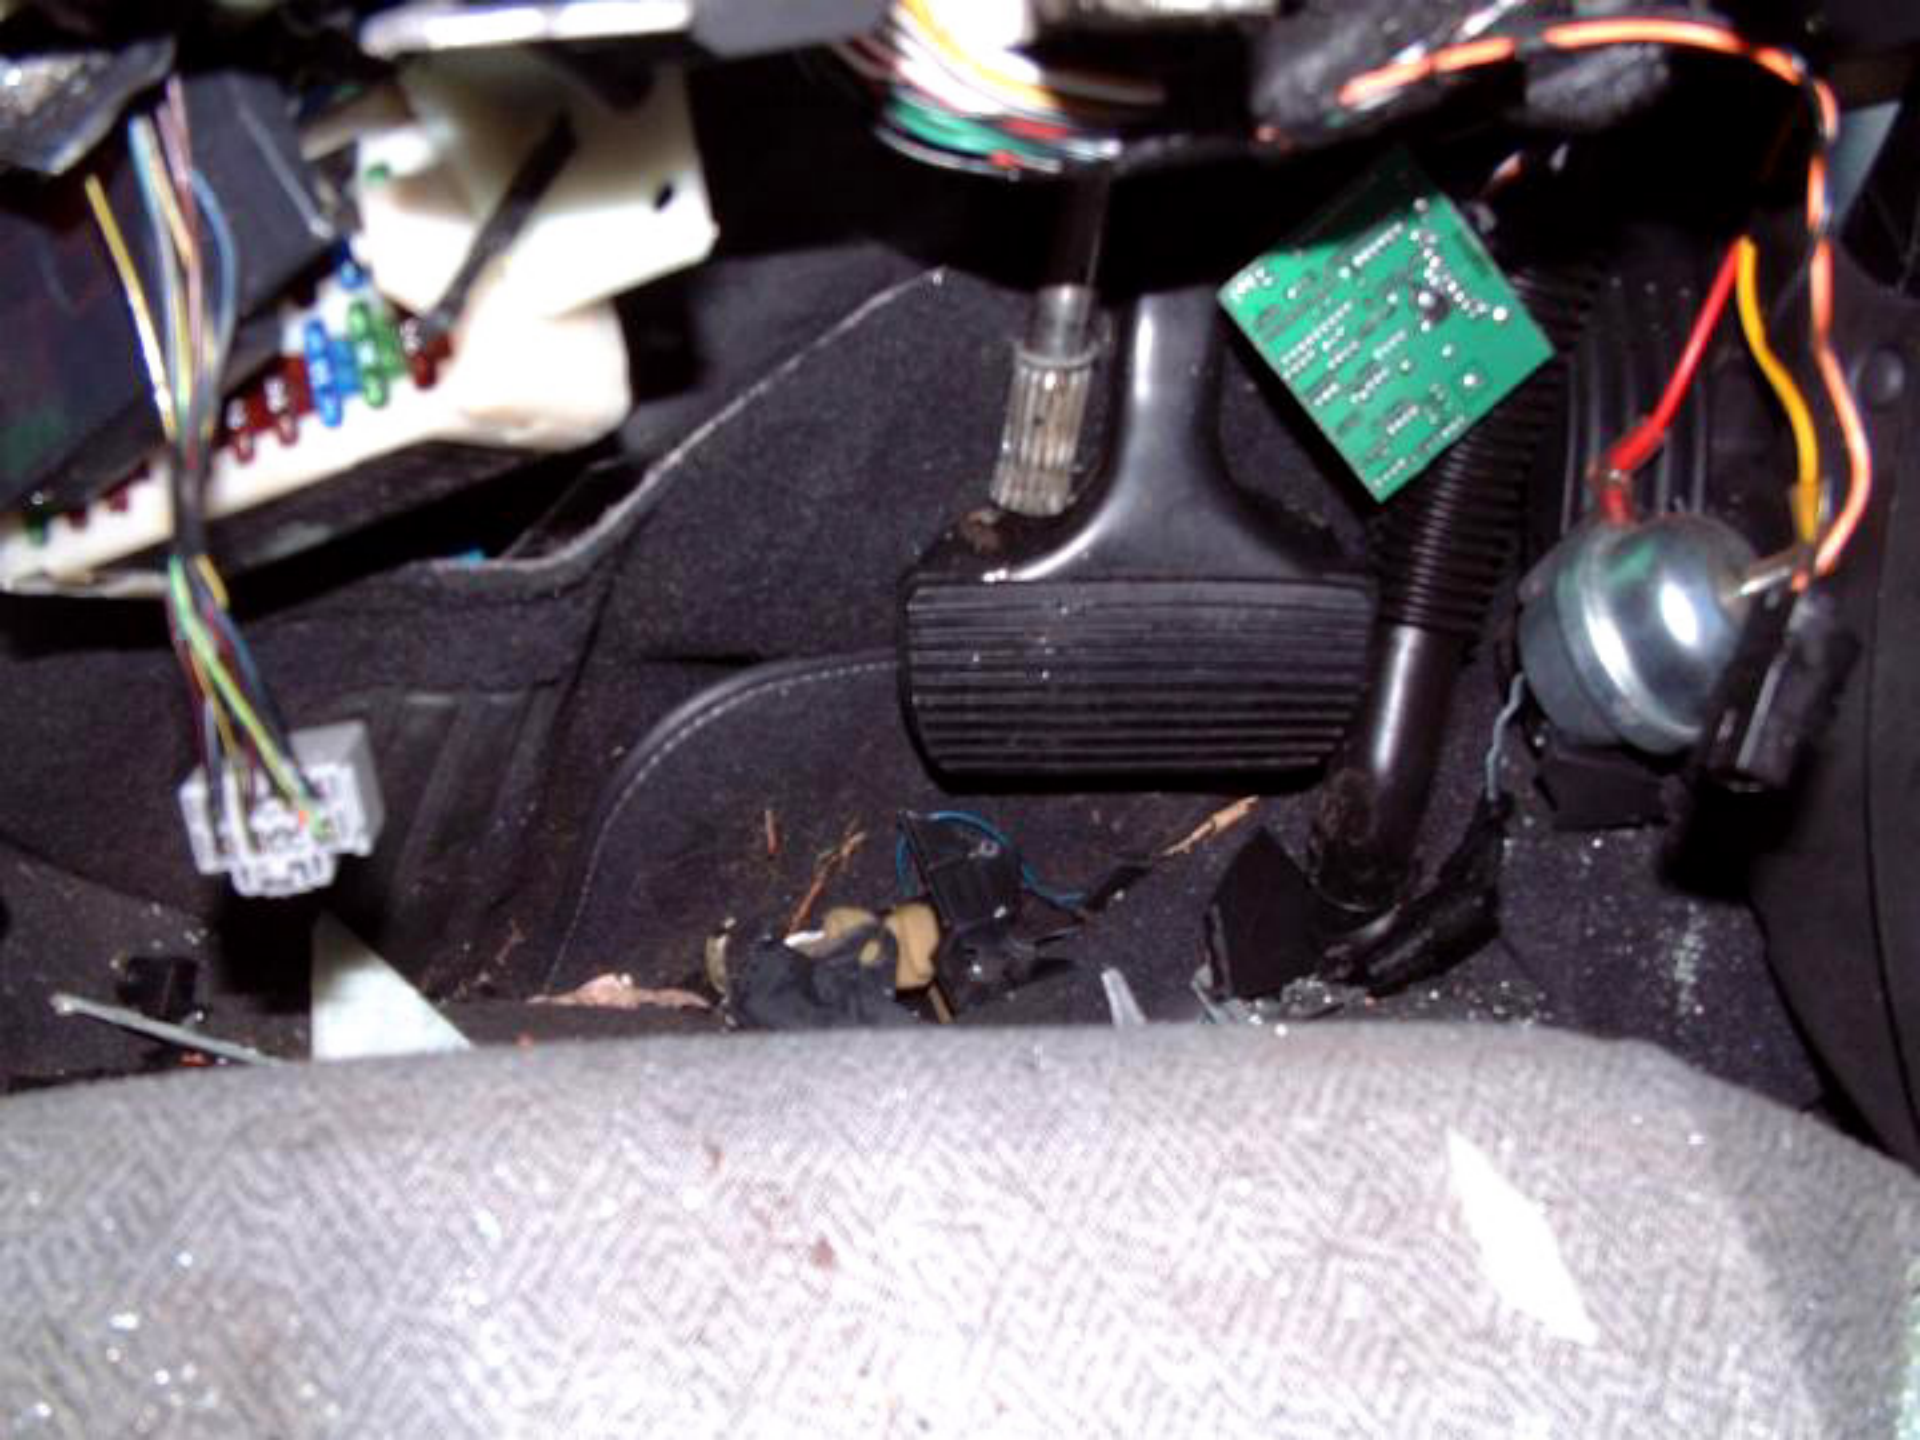
[73](#) During the frontal impact, the unbelted female driver moved forward relative to the vehicle interior into the airbag. [74](#) [75](#) She sustained a fractured nose, possibly from contact with the airbag or the upper instrument panel. [76](#) She sustained fractures to the anterior aspects of all ribs with bilateral flail chest, probably from steering-wheel loading through the airbag. She sustained unspecified spinal fractures at the level of T3-T4 from an unknown source. [77](#) [78](#) She sustained lacerations to the lateral aspect of the left forearm, possibly from contact with the driver door and/or door glass, or from contact with the upper portion of the instrument panel. She also sustained lacerations to the lateral aspect of the

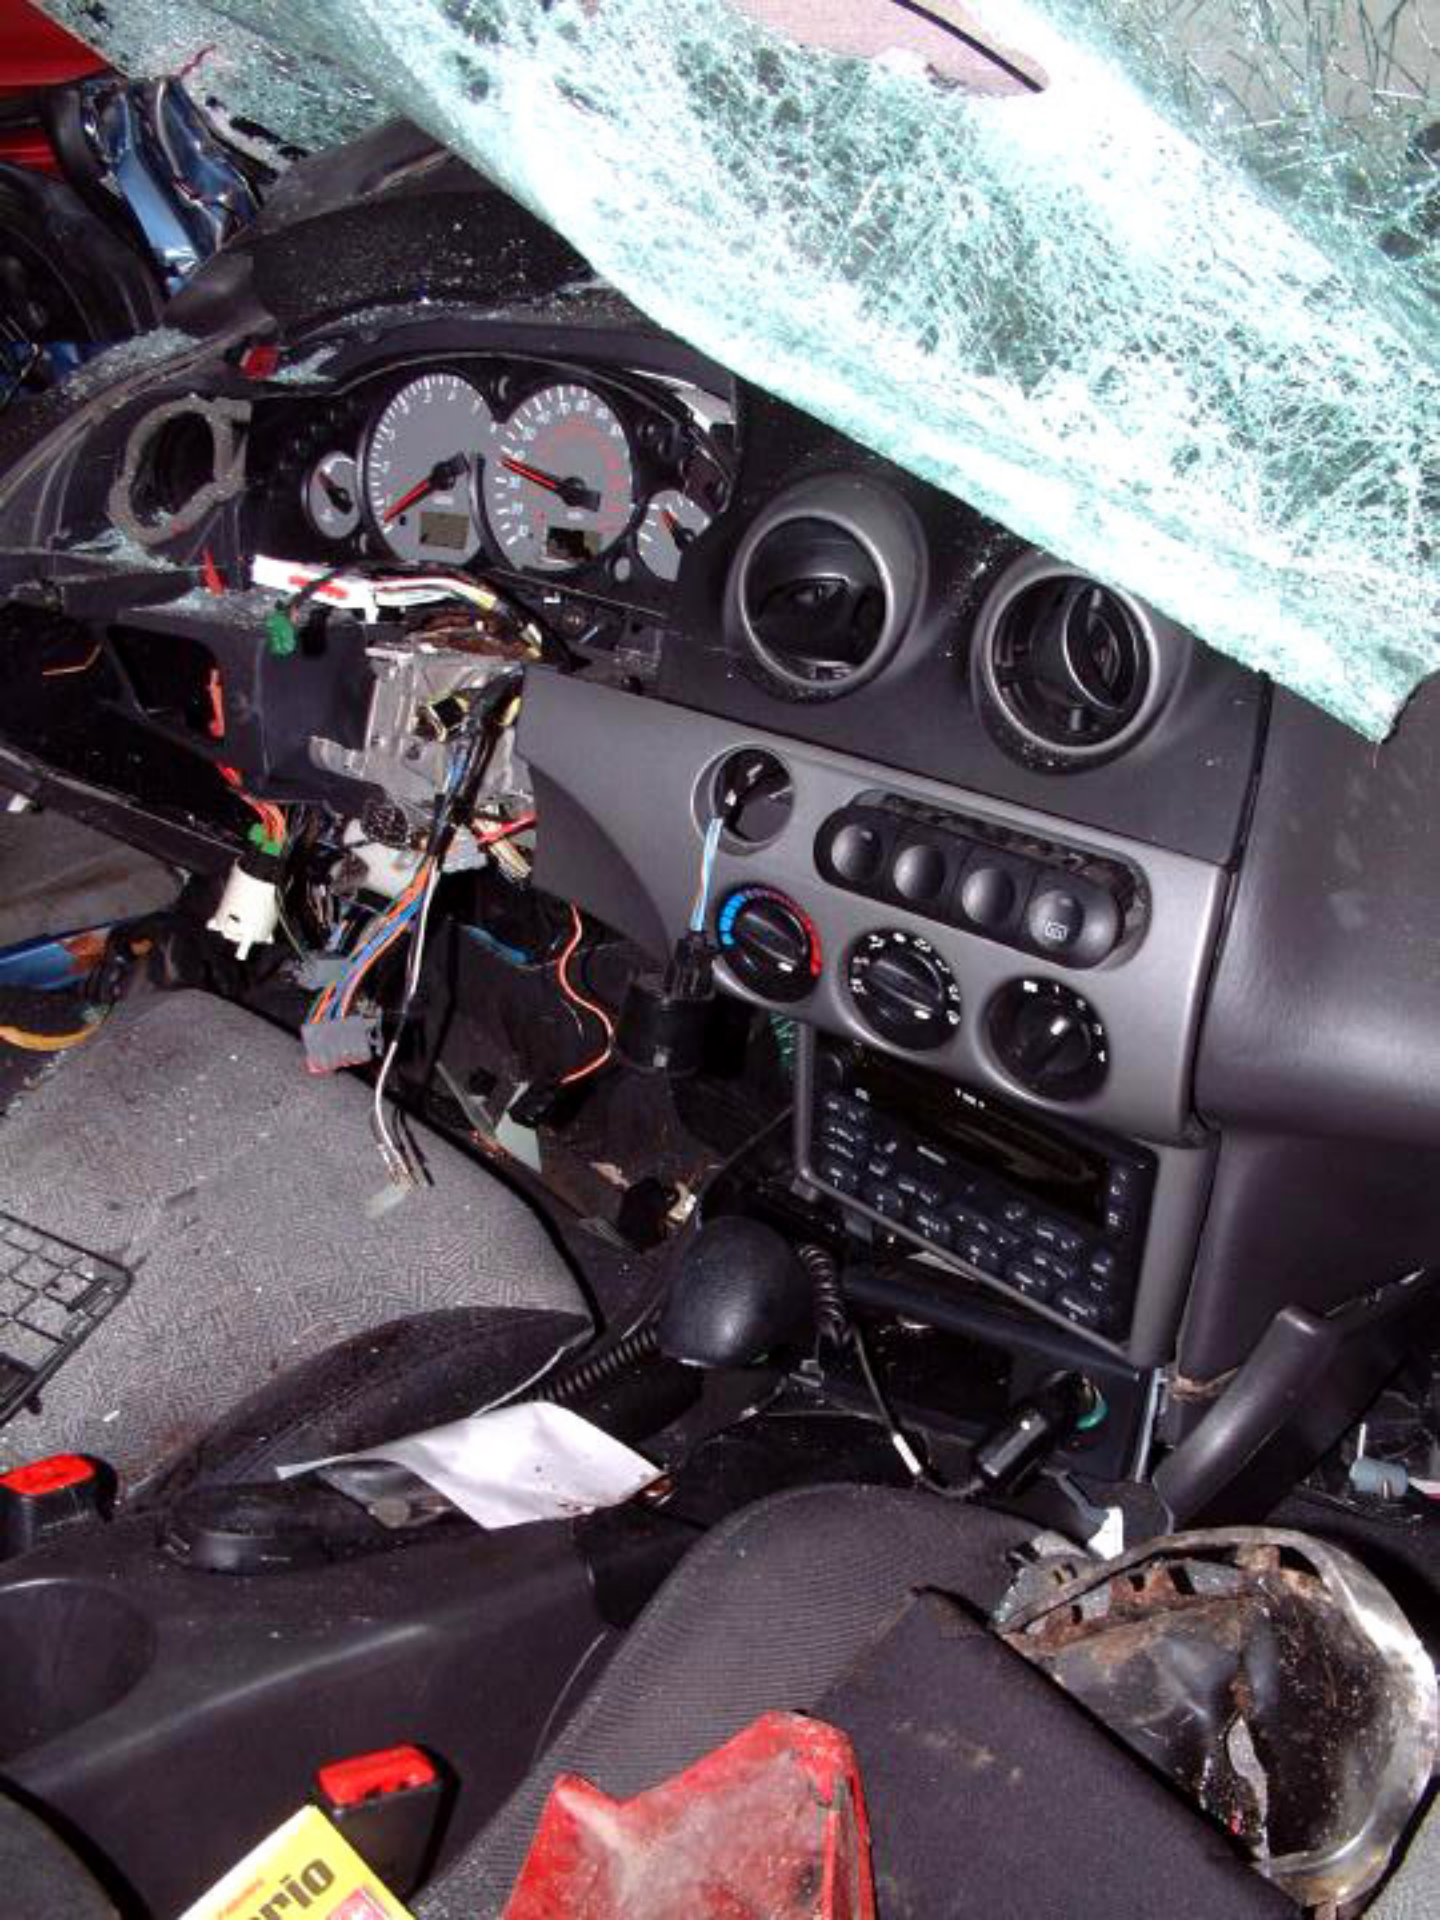
right thigh from an unknown source. [79](#) She sustained compound fractures of the distal left femur, and proximal fractures of the left tibia and fibula, from contact with the knee bolster, as indicated by scuff marks on the bolster. She also sustained a laceration to the right knee, from contact with the knee bolster. [80](#) In addition, she sustained a laceration to the lateral aspect of the right ankle, probably from contact with the brake or accelerator pedals, and a dislocation of the right ankle, probably from contact with the brake pedal.
